Safety Lines

ENGINEERING SAFETY NEWSLETTER, OCCUPATIONAL SAFETY AND HEALTH SERVICE

No. 57, March 2003

Some D-Type Boilers Were Found To Have Potentially Dangerous Cracks in Welds

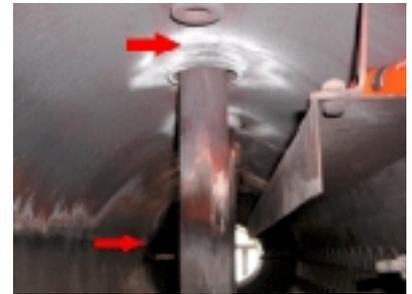
Three D-Type boilers were recently examined and substantial cracks were found in the welds between the drum shell and both dished ends of all three steam drums. The cracks in the circumferential weld run in the transverse (drum axial) direction and extend across the entire weld width and into the surrounding metal (see Figures 1 and 2). The depth of the cracks has not been established. However, in two boilers, cracks are believed to be of substantial depth.

Figure 1. General location of cracks

Operators of D-Type boilers should conduct an inspection of the weld areas in the steam drum of these boilers in particular, as soon as possible. It is recommended that Non-Destructive Testing (NDT) methods be used to examine the welds for any signs of cracking. In the case of any cracks being detected, further NDT examination may need to be carried out to determine the extent of the damage. Structural integrity of the boiler would subsequently need to be established by a competent person, prior to the boiler being put back into service, unless the affected areas are repaired/restored to the original design requirements.

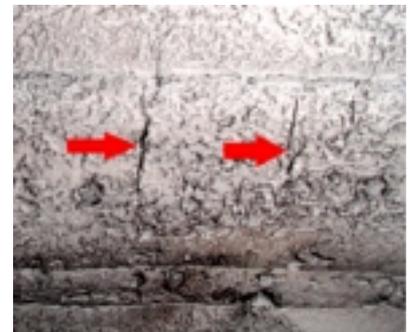
Substantial cracks were also found in the toe of the circumferential weld of the water-level chamber standpipe to the drum shell. Cracks of this type could lead to rupture of pressure components, possibly resulting in death or serious injuries and substantial damage to property.

Figure 2. Cracks in the steam drum to dish end weld
